# OPERATION PLUMBBOB

NEVADA TEST SITE  
MAY-OCTOBER 1957

Project 3.5a

ISOLATION OF STRUCTURES FROM GROUND SHOCK

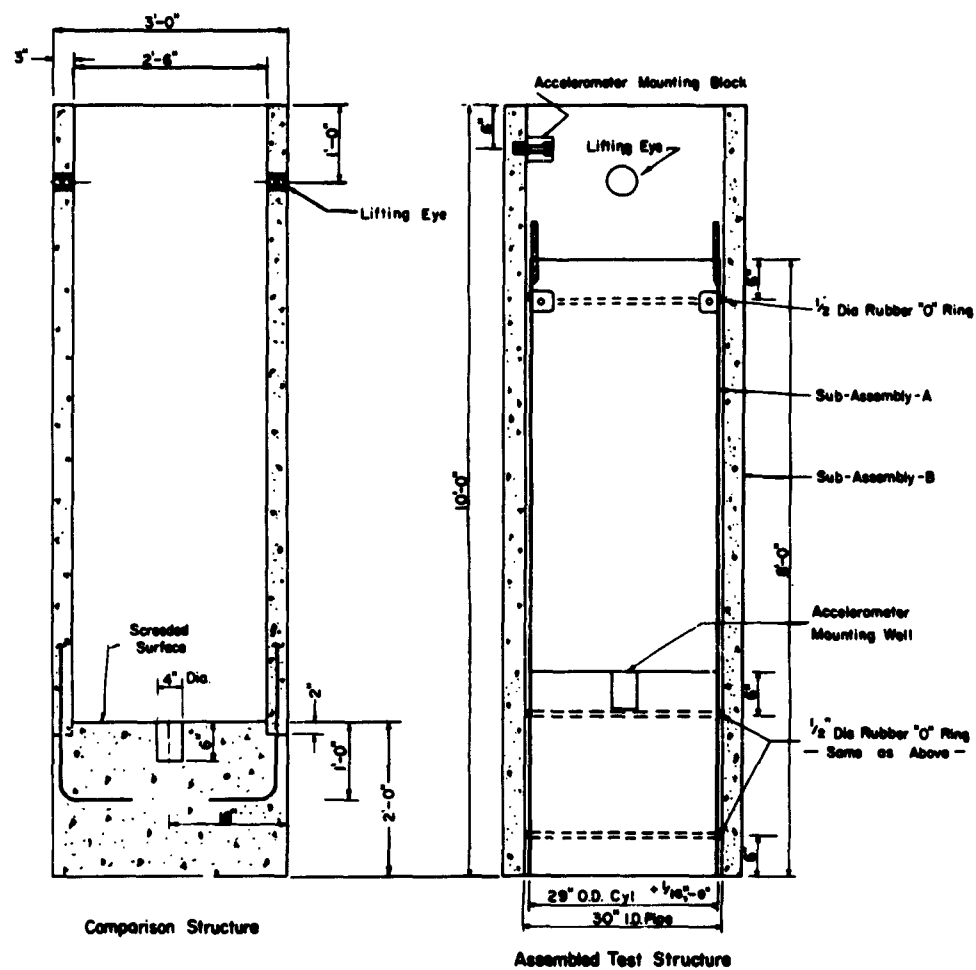
Figure 2.1 Comparison structure and test structure.

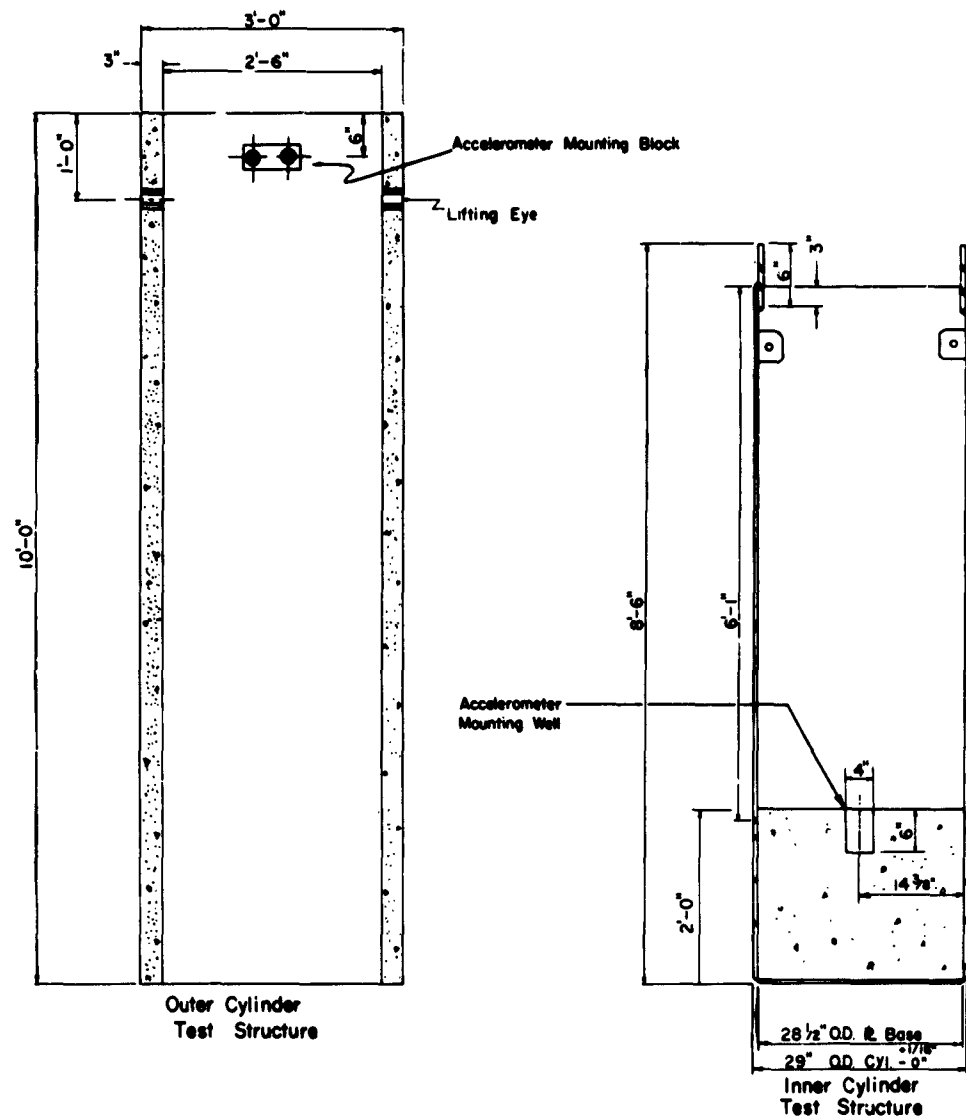
Figure 2.2 Cross section of inner and outer cylinders, test structures.

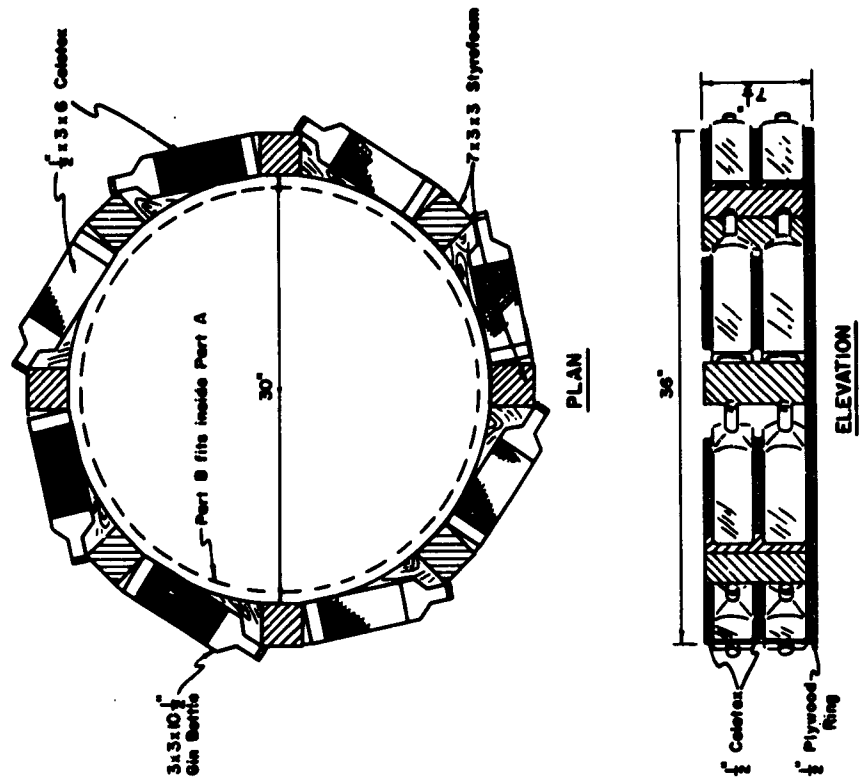
Figure 2.7 Plan and elevation views of base for outer cylinder.

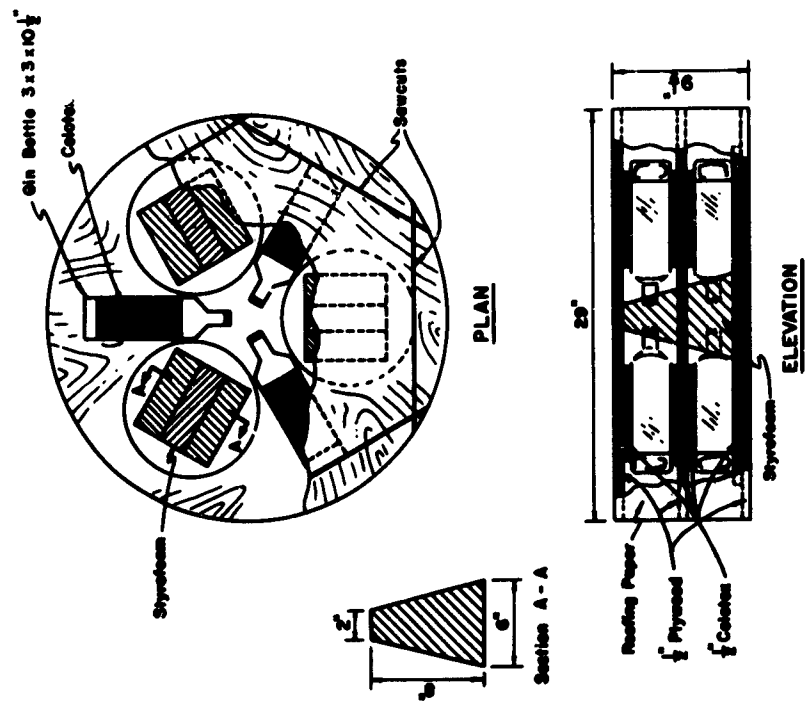
Figure 2.6 Plan and elevation views of base for inner cylinder.

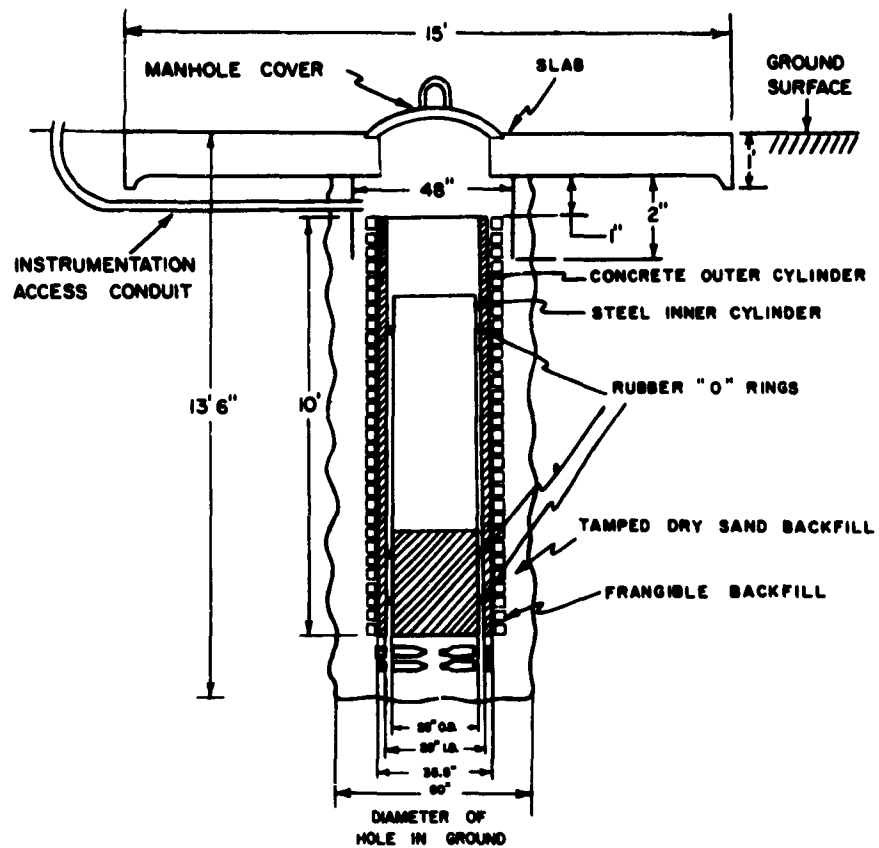
Figure 2.13 Cross section of test structure in place.

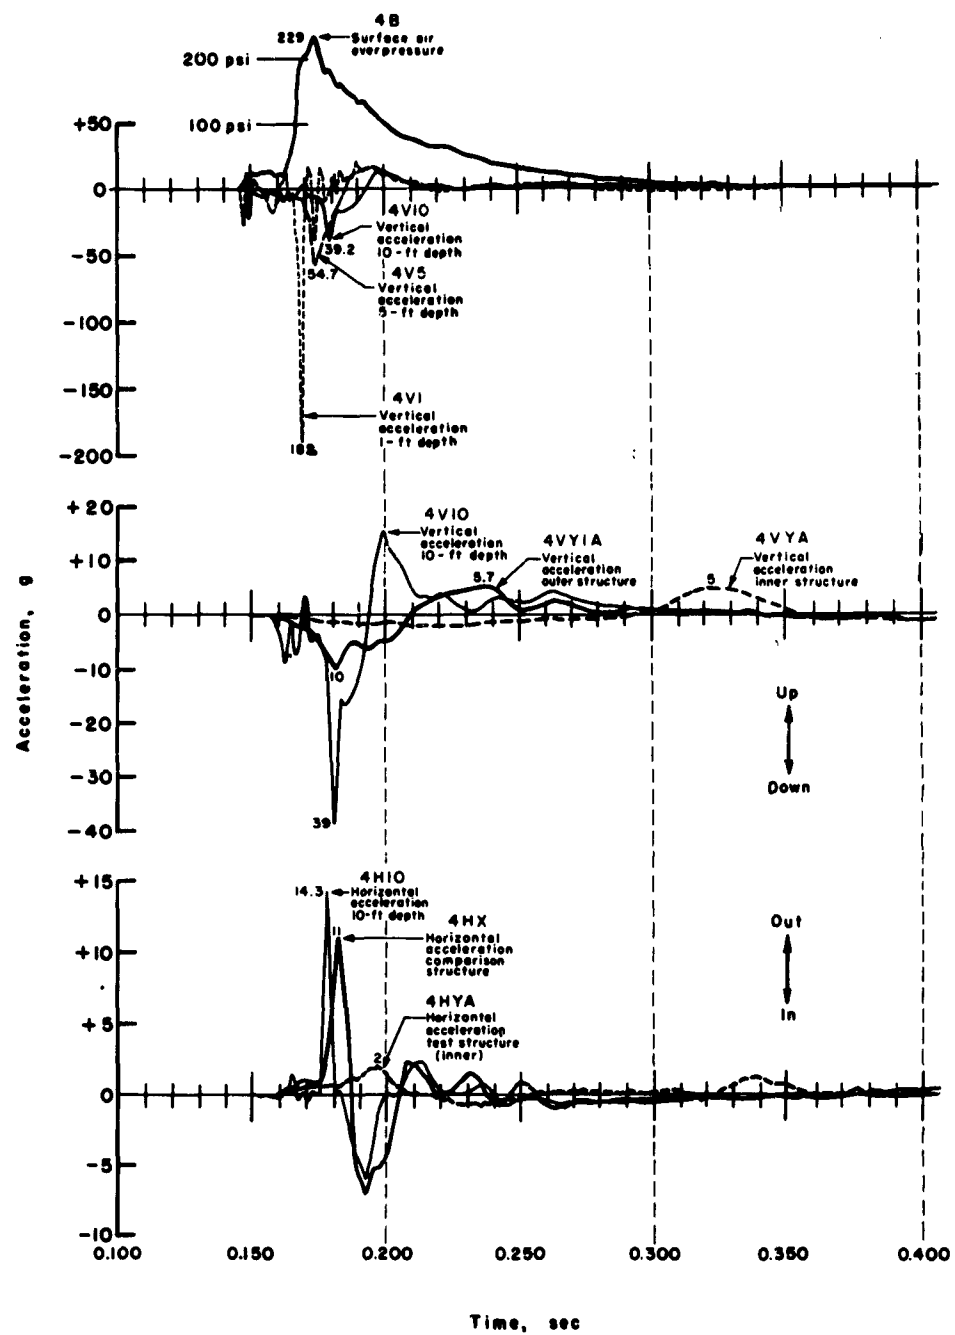
Figure 3.1 Ground and structure acceleration at 229-psi surface overpressure level.

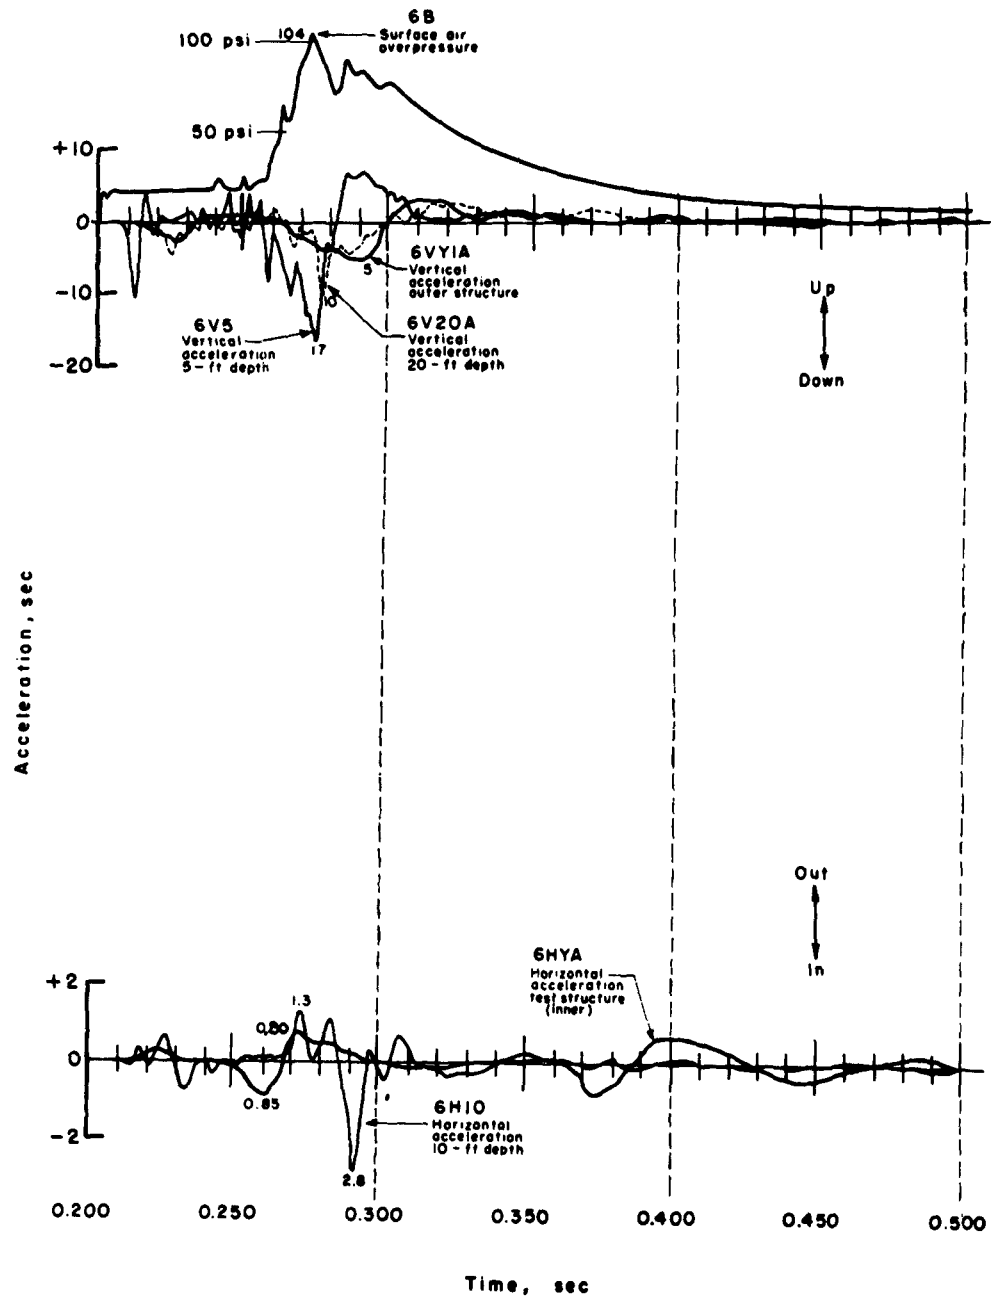
Figure 3.2 Ground and structure acceleration at 104-psi surface overpressure level.

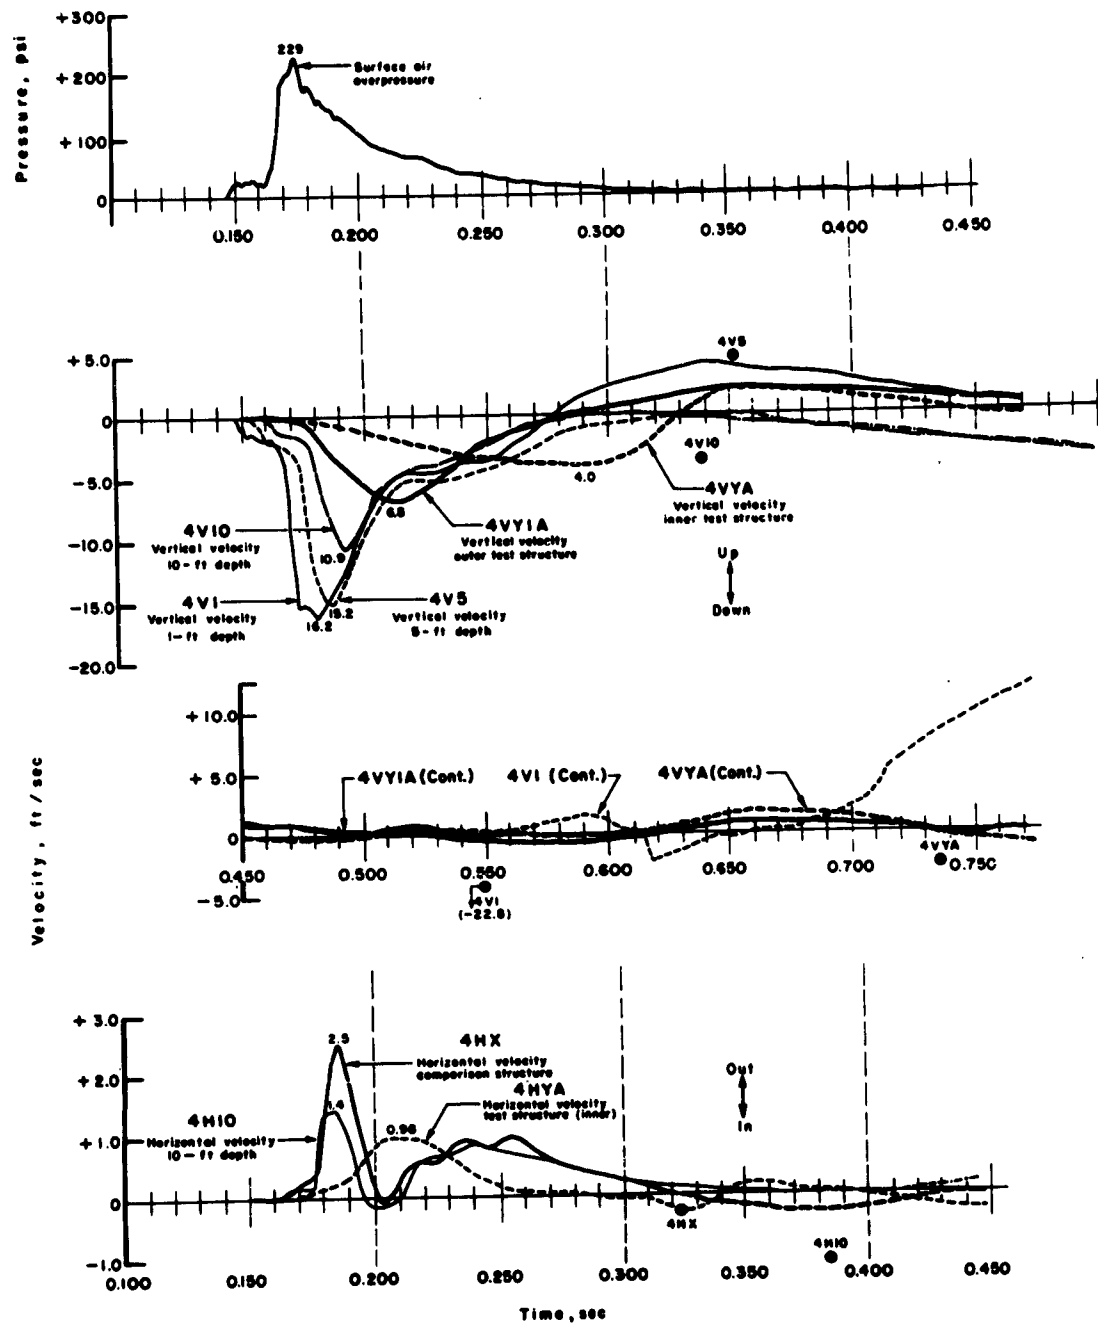
Figure 3.3 Ground and structure velocity at 229-psi surface overpressure level.

On Figure 3.3 it should be noted that the striking similarity in the surface overpressure waveform and the vertical velocity waveform at 1-foot depth is typical of kiloton tests.

The only suggested explanation for the fact that, in the bottom graph of Figure 3.3, the horizontal velocity of the comparison structure is larger than that of the soil at 10-foot depth is the possibility that the soil-sand-structure complex may have had a resonant frequency in the neighborhood of the frequency of the applied impulsive force. The records were carefully checked, and no instrumental or analytical errors were found.

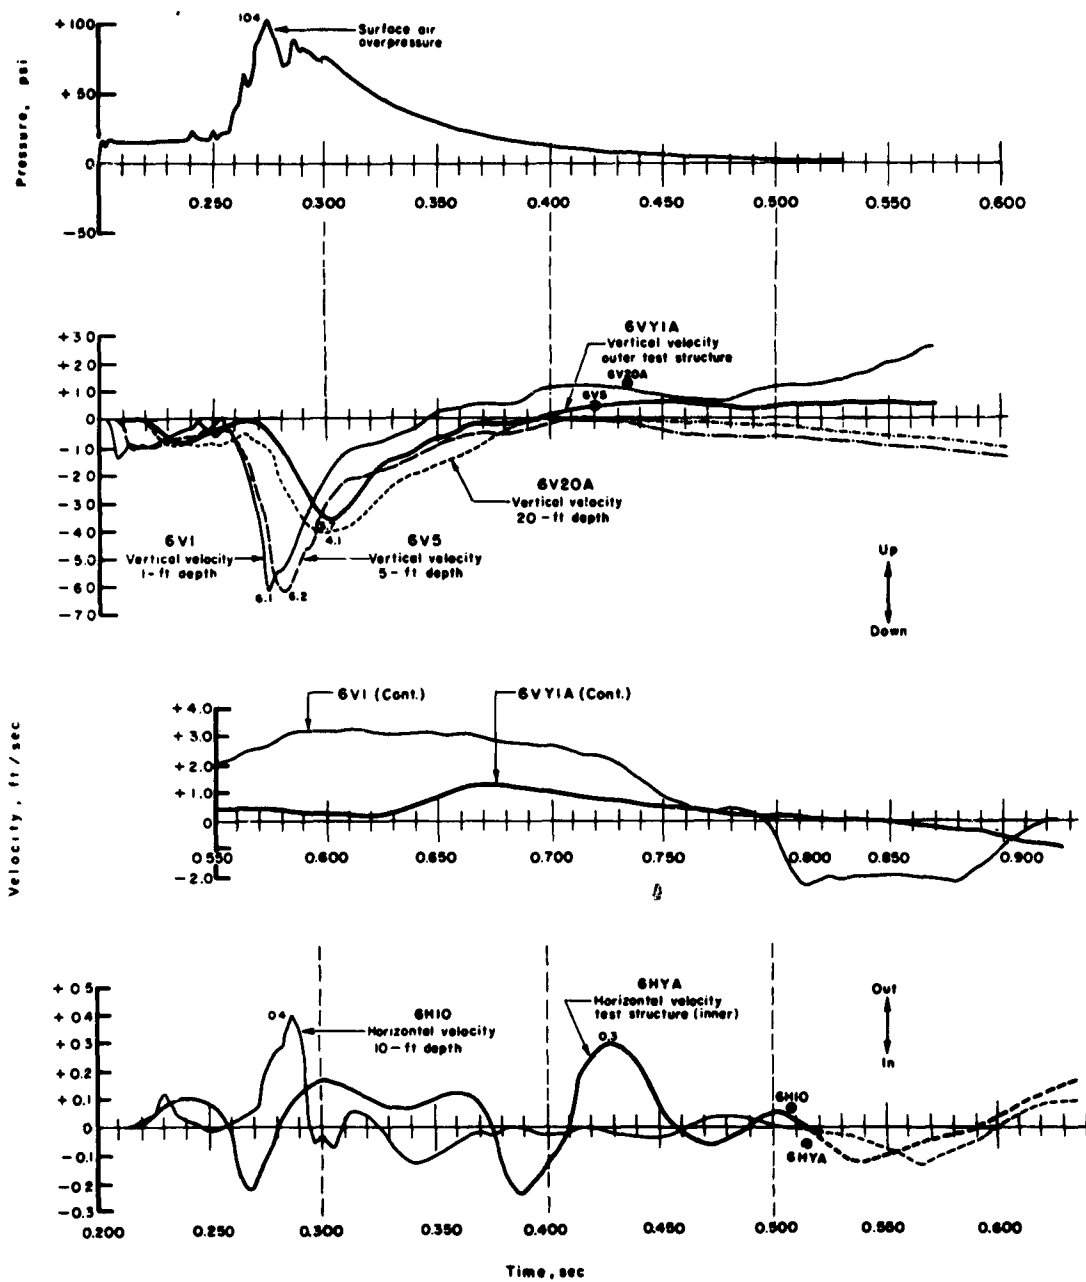
Figure 3.4 Ground and structure velocity at 104-psi surface overpressure level.

In Figure 3.4, the striking similarity of waveform between the surface overpressure and the vertical velocity is again apparent. In the lower graph of Figure 3.4, the sinusoidal aspect of the structure velocity at about 0.4 second probably indicates a resonance determined essentially by the mass of the inner structure and the resilience of the O-rings. It should be noted that the magnitude of these velocities is small and is in fact trivial compared with either the vertical velocity at that radius or with the horizontal velocities of the structures nearer the burst.

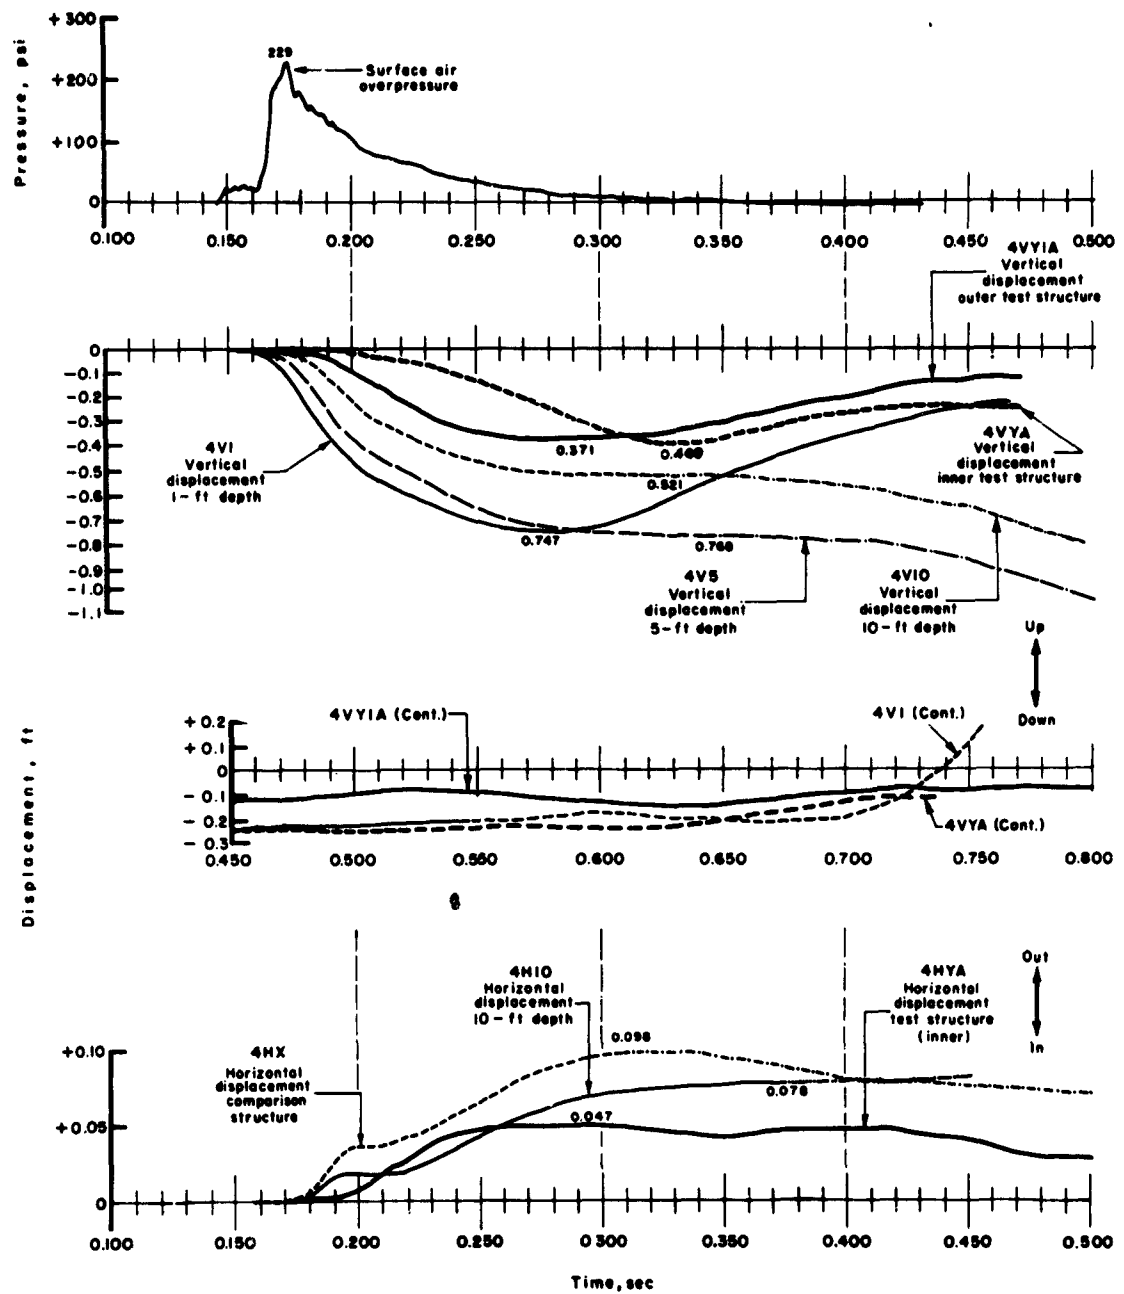
Figure 3.5 Ground and structure displacement at 229-psi surface overpressure level.

The bottom graph of Figure 3.5 permits comparison of the horizontal displacements of the comparison structure, test structure, and 10-foot free-field depth. It will be noted that the comparison structure apparently moved considerably more than the free field. This was a surprising result and led to a meticulous review to be sure no instrumental or computational error had occurred. The accelerometers from which these displacements were derived were identical Wiancko gages both with 30-g rated values (and hence registering above 30 percent of rating as shown on the bottom graph of Figure 3.1) and with natural frequencies of 85 cps. These gages were connected to identical galvanometers having natural frequencies of about 300 cps. Thus, a careful check of the instrumentation and the data reduction confirmed the validity of the curves.

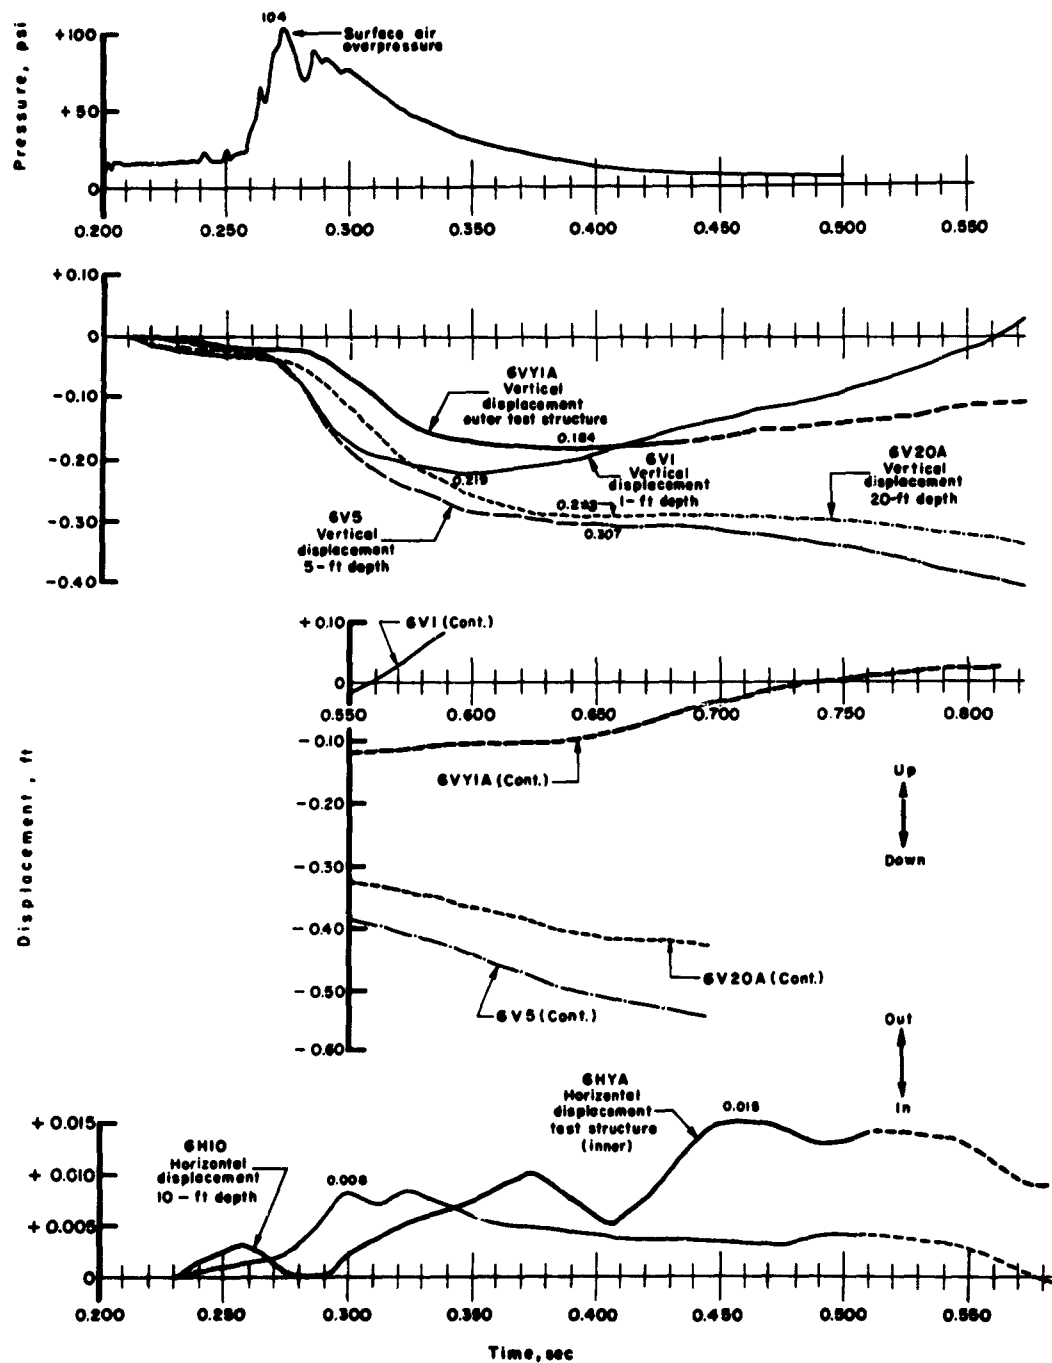
Figure 3.6 Ground and structure displacement at 104-psi surface overpressure level.

In the bottom graph of Figure 3.6 the horizontal displacement of the inner test structure is compared with the 10-foot free-field displacement. The oscillation of the inner structure is presumed to be at the natural frequency determined by the mass of the inner structure and the resilience of the rubber O-rings separating it from the outer structure. It is to be noted that the displacement scale had to be expanded greatly to make these curves visible.

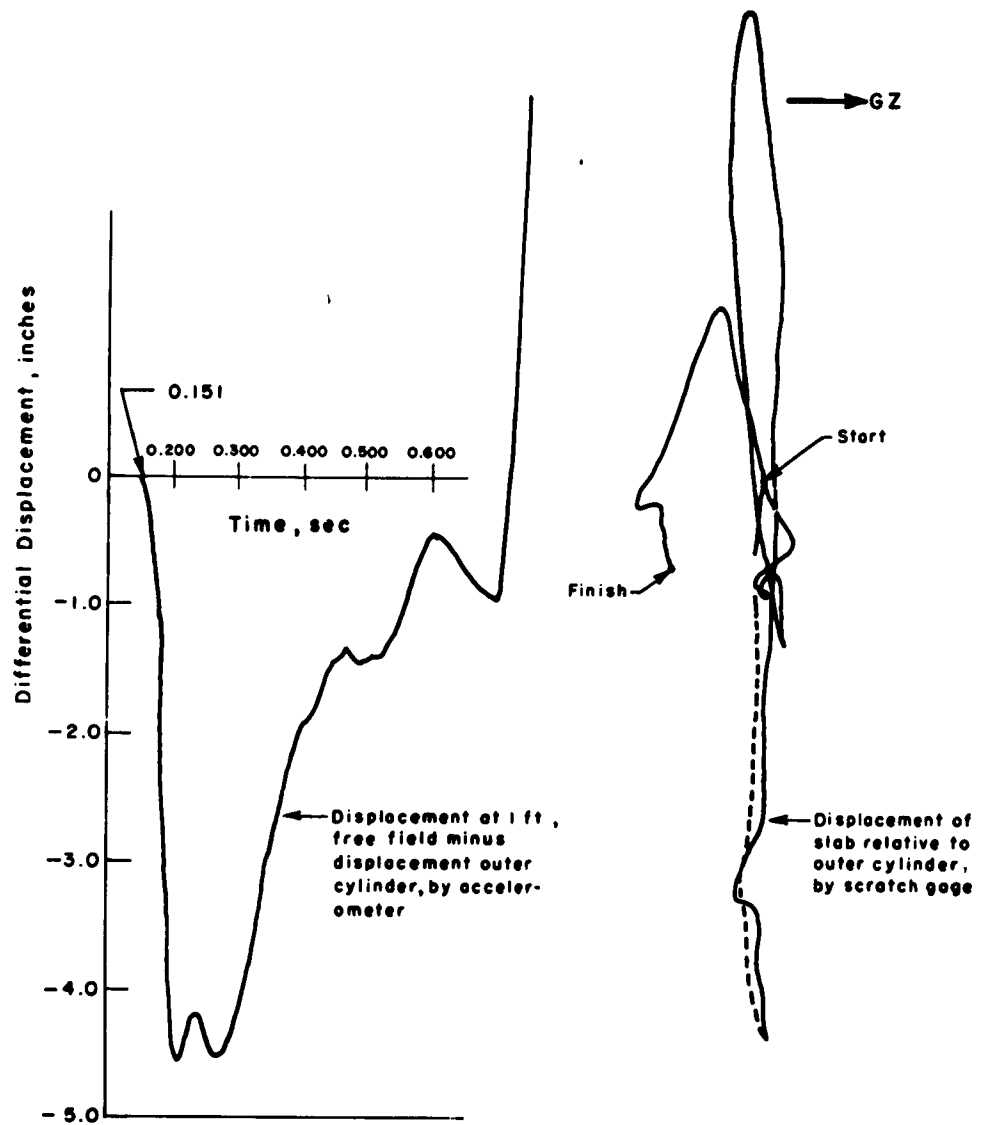
Figure 3.7 Comparison of relative displacements in Structure 1.

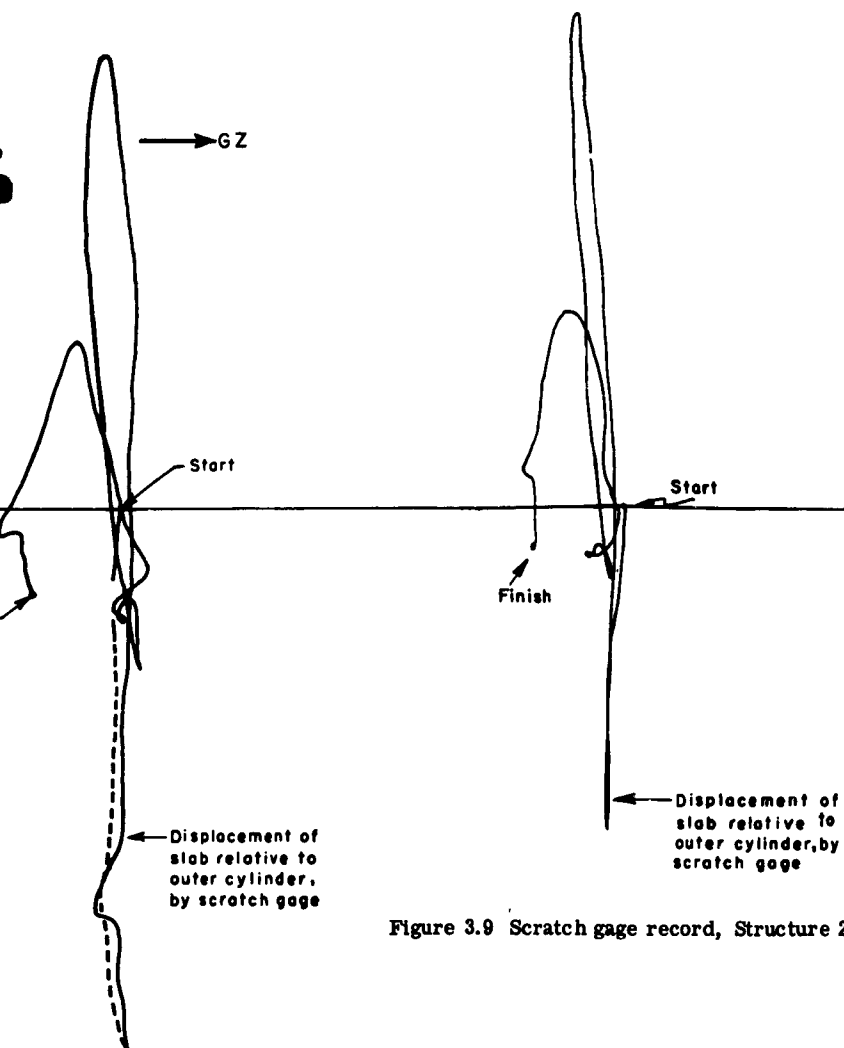
Figure 3.9 Scratch gage record, Structure 2.

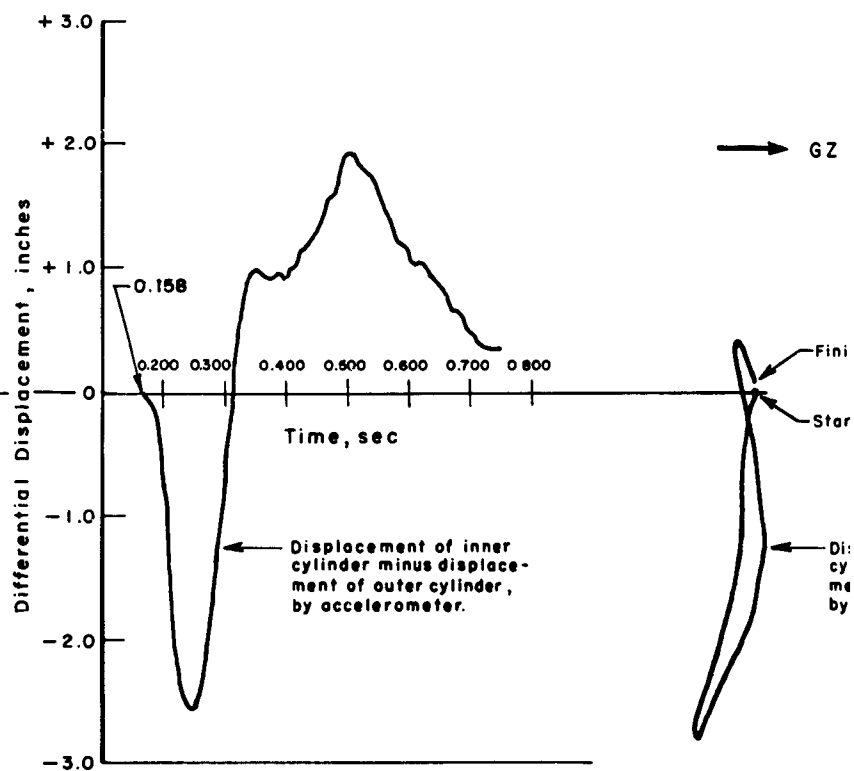
Figure 3.10 Comparison of relative displacements in Structure 3.

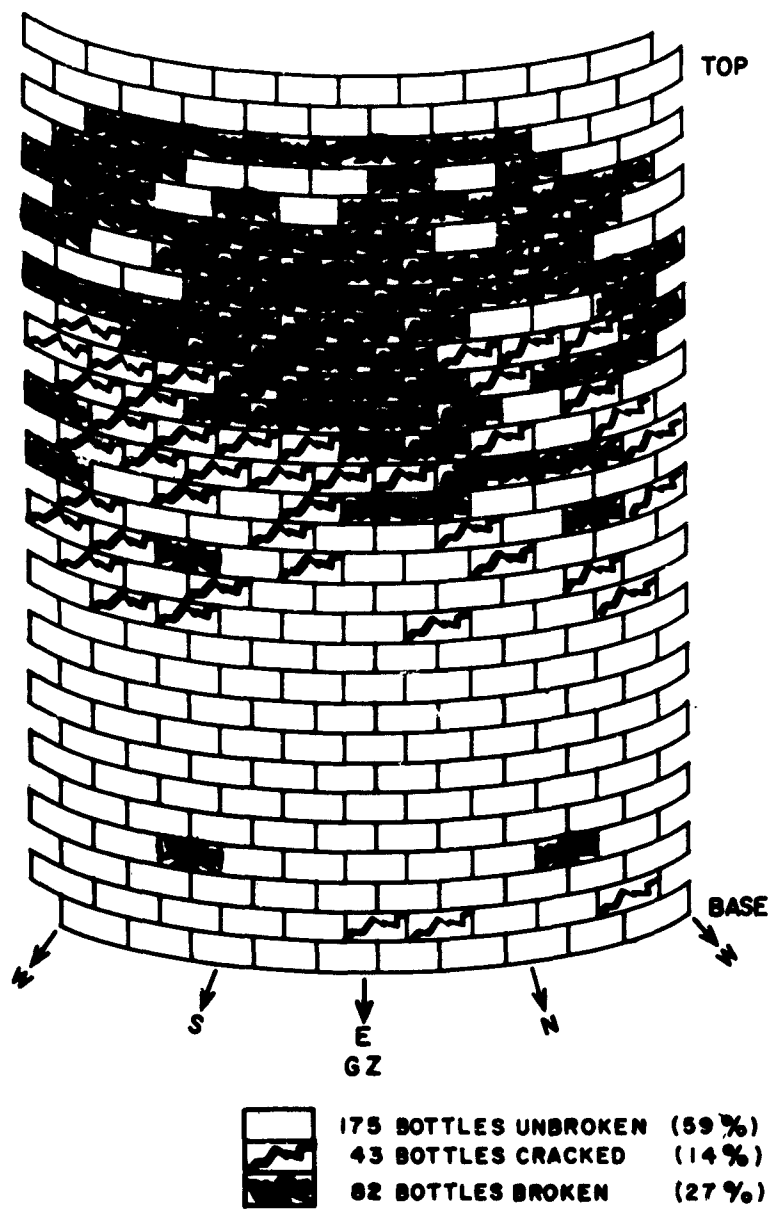
**Figure 3.11** Developed surface of excavated Structure 3 indicating condition of bottles.

**3.4.1 Structure 3.** The results of excavating Structure 3 is illustrated by the schematic diagram of Figure 3.11, which is a developed view of the bottles surrounding the sides of the structure. It can be seen from the figure that 27 percent of the bottles were broken, that there was no significant azimuthal dissymmetry, and that there was considerably more damage in the top half than in the bottom half. Actually, it is suspected that the broken bottles in the lower rows were probably broken during placement, inasmuch as the dry sand was vibrated in place with eccentric vibrators used for concrete placement, and it was difficult for a workman to control the position of the vibrator, particularly in the deeper parts of the hole. The photographic evidence equivalent to Figure 3.11 is displayed in Figures 3.12 and 3.13.

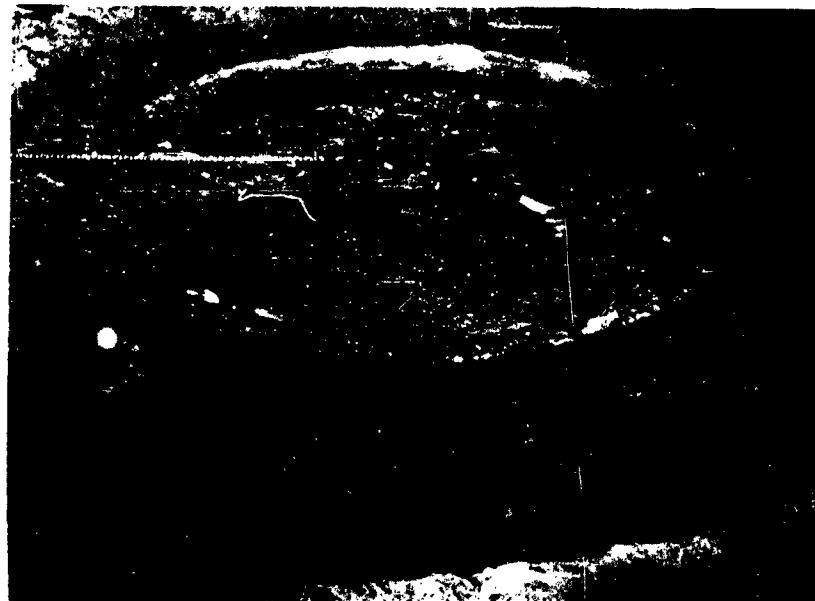
**Figure 3.21 Bottom of Structure 1 and subbase showing displaced O-ring.**

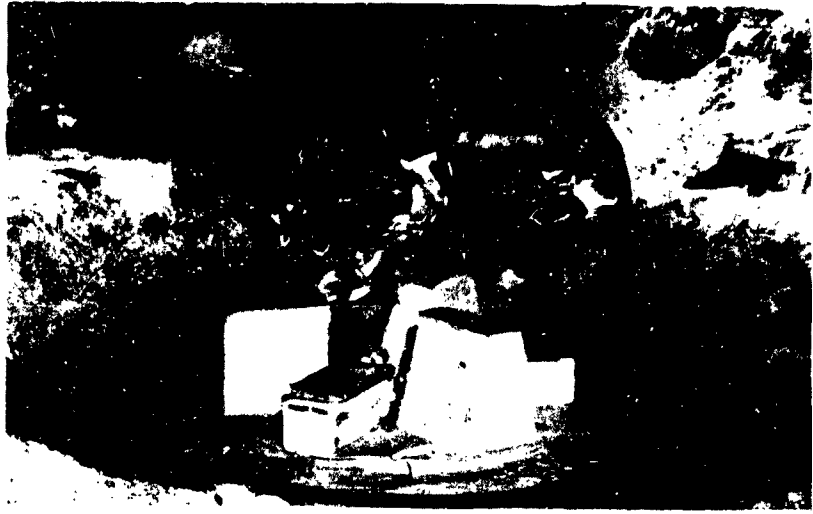
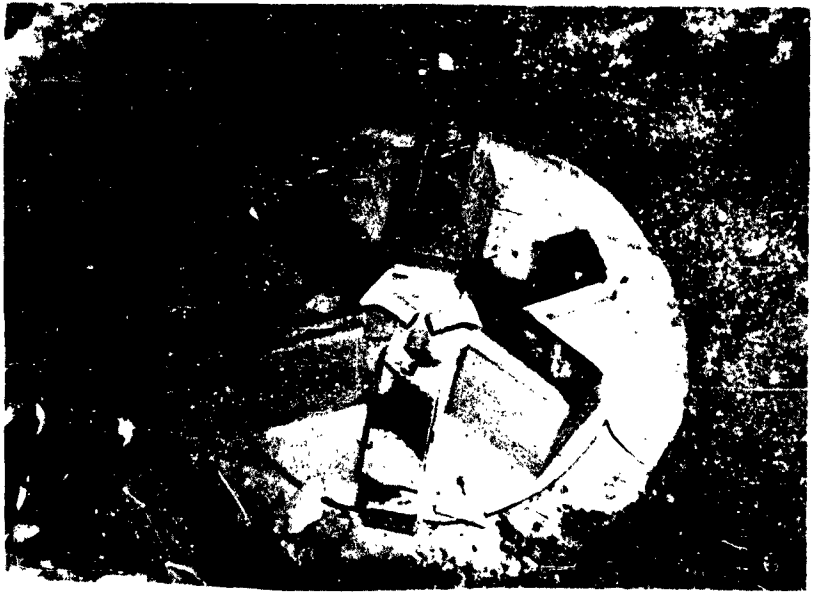
**Figure 3.22 Inner subbase of Structure 1 exposed.**

The inner subbase, as shown in Figure 3.22, had two bottles in the top row and one bottle in the bottom row unbroken. One of the unbroken bottles in the top row was found to be one-quarter full of water. Since, in fact, the bottles had been received empty but capped and sealed, there was a minor mystery. It is presumed that, during the rainy season, this bottle had an external water pressure on it amounting to several feet of head and that the seal was not perfect. Then, since the bottle was on its side, as the water level receded below the bottle, the water that entered was trapped inside.

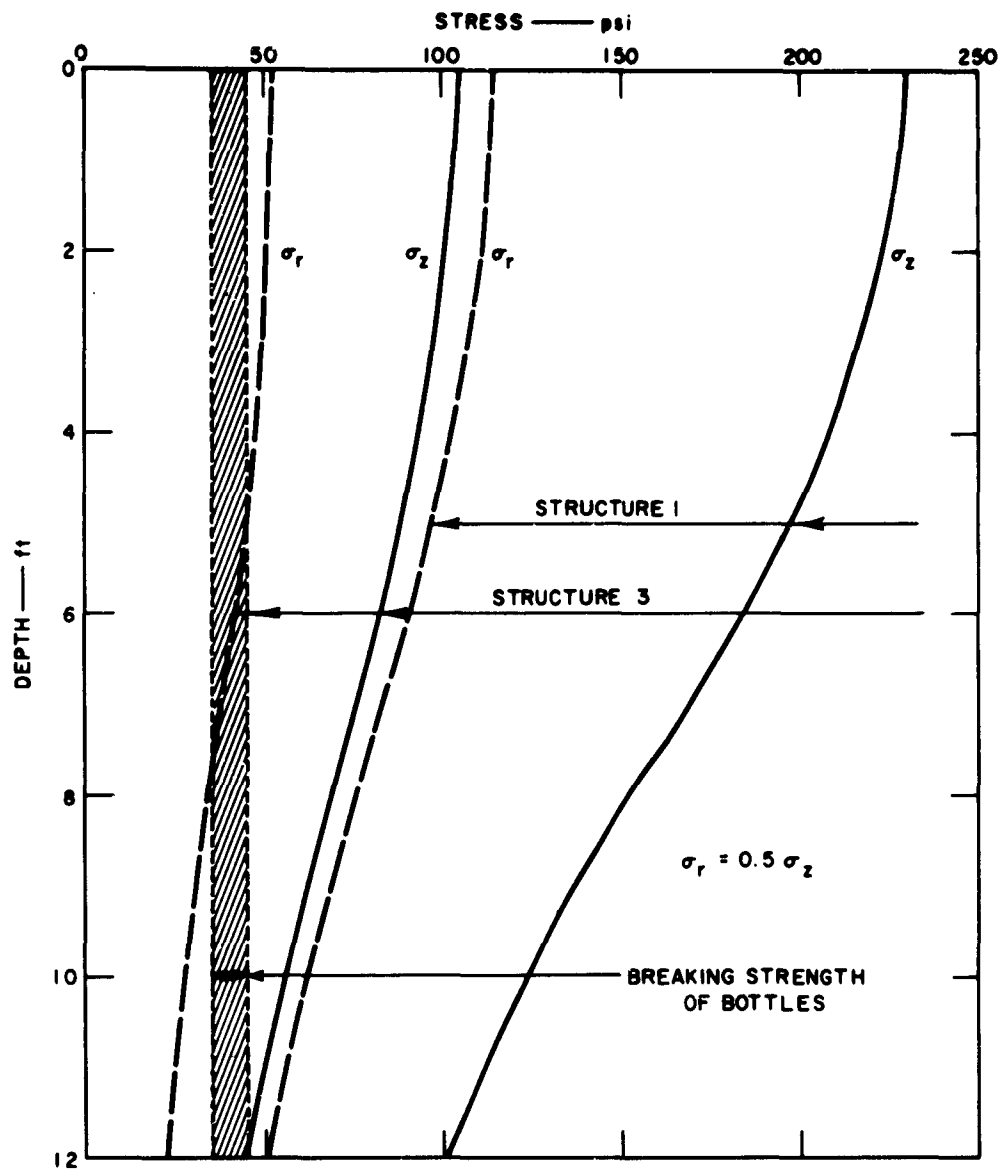
Figure 3.23 Lateral stress as a function of vertical stress.

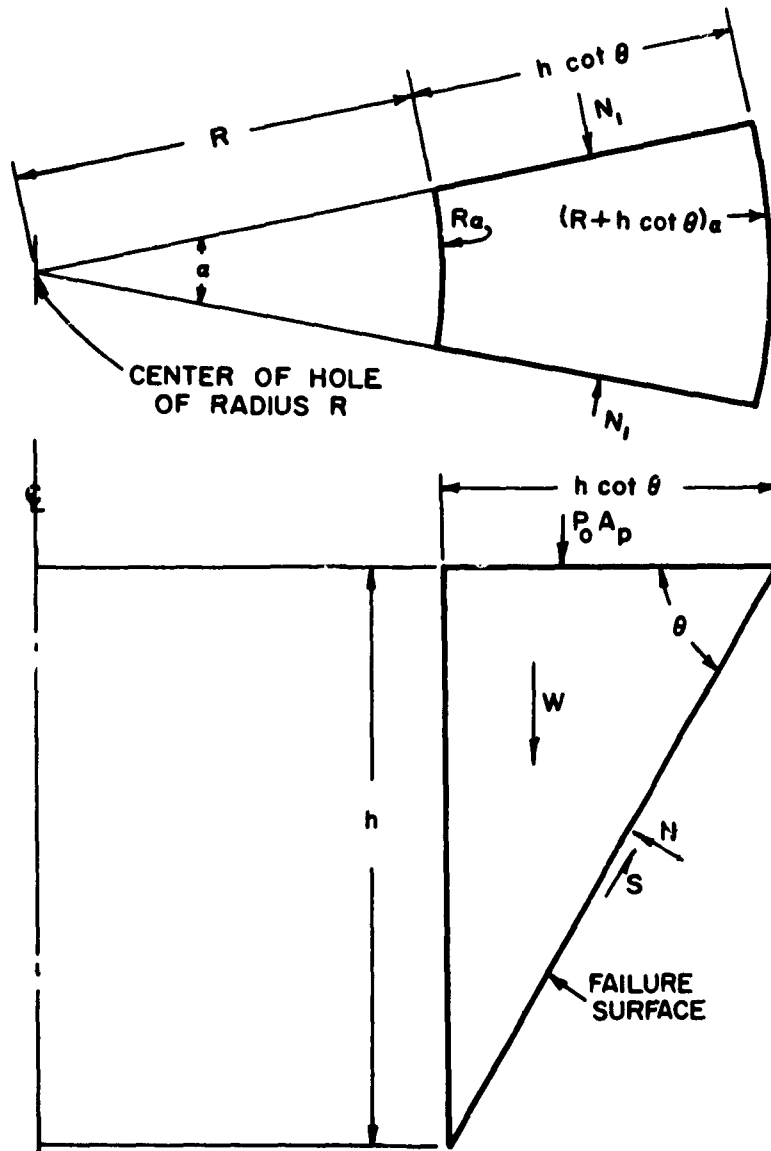
Figure 3.24 Diagram of failure wedge.

If the frangible backfill fails at the values of  $\sigma_r$  given above, the soil deforms and failure surfaces appear. In the usual soil mechanics approach, a region of plastic equilibrium is assumed, and the analysis proceeds to determine the extent of the region and the boundary forces required. It is no longer possible to assume that the sand and clay act together as a unit. So much motion may occur in the sand that there is little pressure between the sand and the clay surrounding it. Actually, the sand may lose contact with the concrete cap, thus reducing the vertical stress and the lateral resistance. Therefore, the clay may fail. In the following, the value of the overpressure  $P_0$  necessary to cause failure around an unsupported hole in a rigid-plastic soil is determined (Figure 3.24). The normal assumptions of soil mechanics are made, i.e.,

Figure 3.24 shows the geometry of the system.  $N$  and  $N_1$  are the forces normal to the planes indicated, and  $W$  is the weight of the soil in the wedge. The shearing force on the plane of failure is given by  $S$ . Useful geometric properties of the wedge are

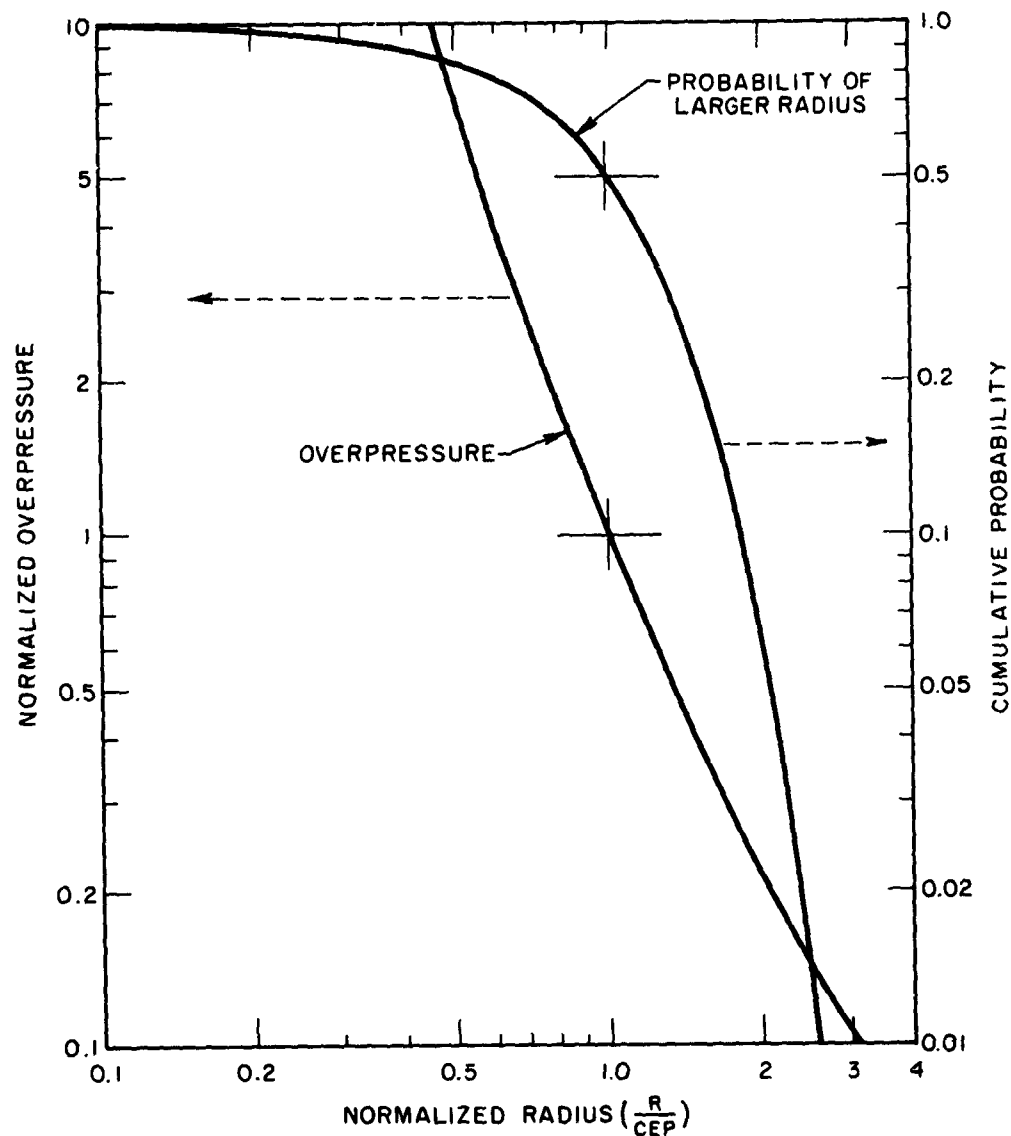
Figure 4.1 Overpressure and probability as a function of radius.
